BUILDING-STRUCTURE INVENTORY FORM

YOUR NAME: Robert Hodder & Martha Demas DATE: August 1989
Sibley Hall

- 1. BUILDING NAME(S): _____
- 2. COUNTY: Cayuga TOWN/CITY: Auburn VILLAGE: _____
- 3. STREET LOCATION: 70 South Street
- 4. OWNERSHIP: a. public b. private
- 5. PRESENT OWNER: Thomas Clary ADDRESS: 70 South St., Auburn
- 6. USE: Original: Residential Present: Professional/Residential
- 7. ACCESSIBILITY TO PUBLIC: Exterior visible from public road: Yes No
Interior accessible: Explain no, by appt. only

70 South Street

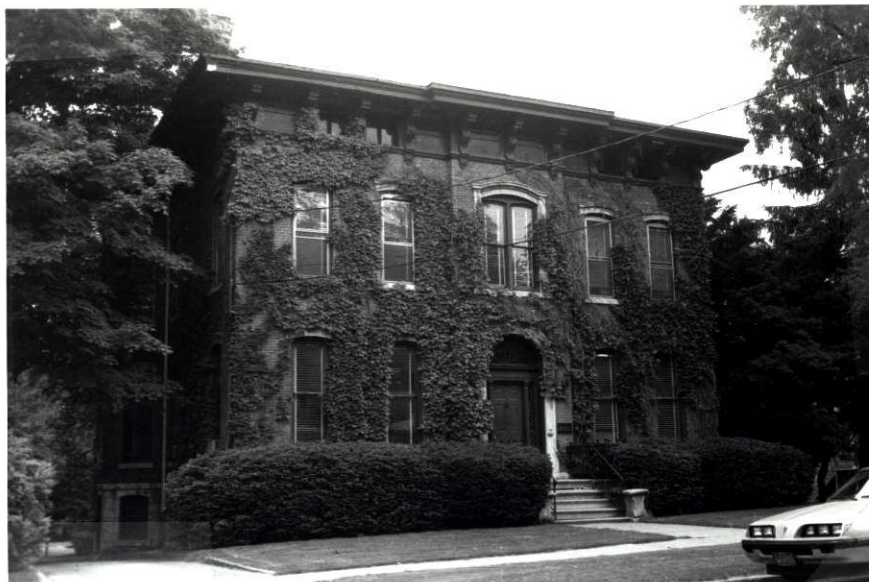
12. PHOTO:

18. This two and one-half story, five-bay, brick residence is of Italianate Style. Its rectangular-massed form features a two-story angled bay on the north elevation and a one-story bay on the south elevation. The wide, overhanging eaves of the shallow hipped roof are supported by brackets. Breaking the heavy cornice band are shallow windows in the attic half story.

The central, slightly projecting entry bay features paired windows at the second story. The windows are all 1/1 sash with segmental-arched molded stone lintels and plain sills. The central entry incorporates Federal and Greek Revival detailing: sidelights with flanking Doric columns crowned by an entablature and semi-circular fanlight. The entry is enframed by a semi-circular stone surround.

At the rear of the house is a two-story brick carriage house.
